RICS
Building Survey

Property address	<input type="text" value="Sample"/>
Client's name	<input type="text" value="Sample"/>
Date of inspection	<input type="text" value="09 March 2018"/>

The subject property is a Grade II listed Georgian terraced town house situated above the Royal Crescent and Circus. The property has been converted back to a single dwelling from 4 flats. We noted a planning application to this effect dated from 2007.

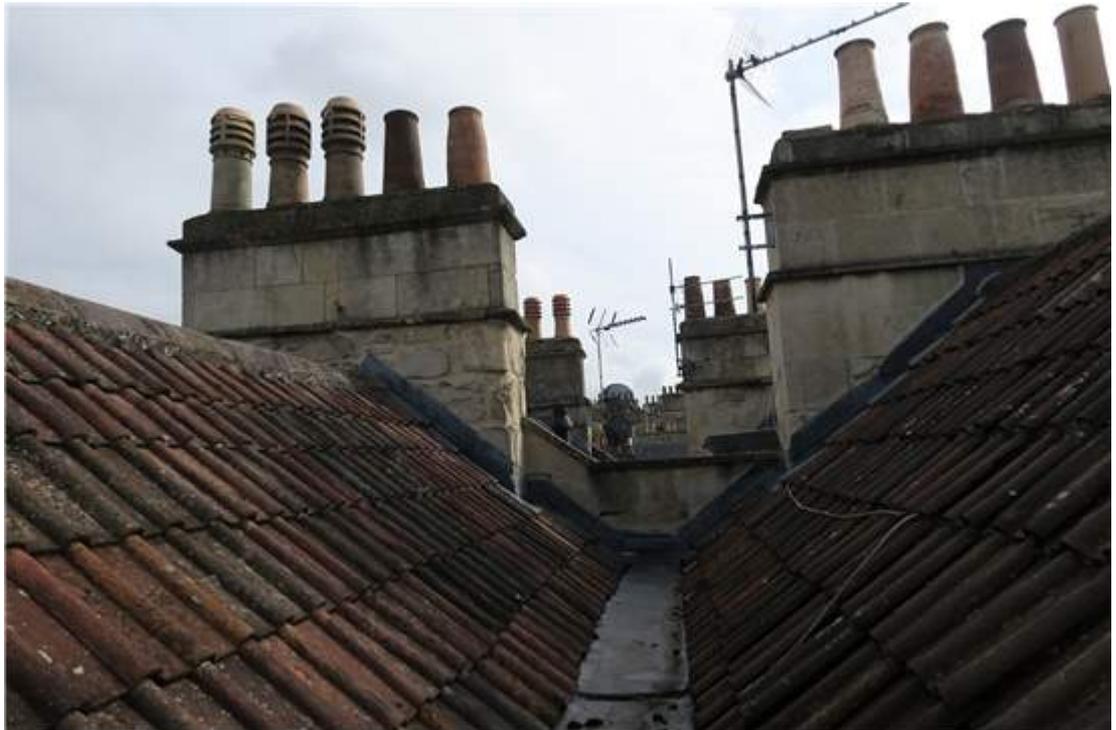
As seen from the roof 'hatchway' to the front inner roof cover we were able to view the central valley gutter and chimney stacks. Inner faces of the double pitched roof have been replaced with clay tile covers and metal flashing details were noted to the base of the stacks and parapet wall. Due to slight damp penetration to timbers below the central valley gutter we would recommend further investigation as valley gutters may need replacement of external weathering. Delamination of stonework was noted to stone clad chimney stacks and all clay pots would benefit from adequate covers to protect against rain ingress yet provide adequate ventilation.

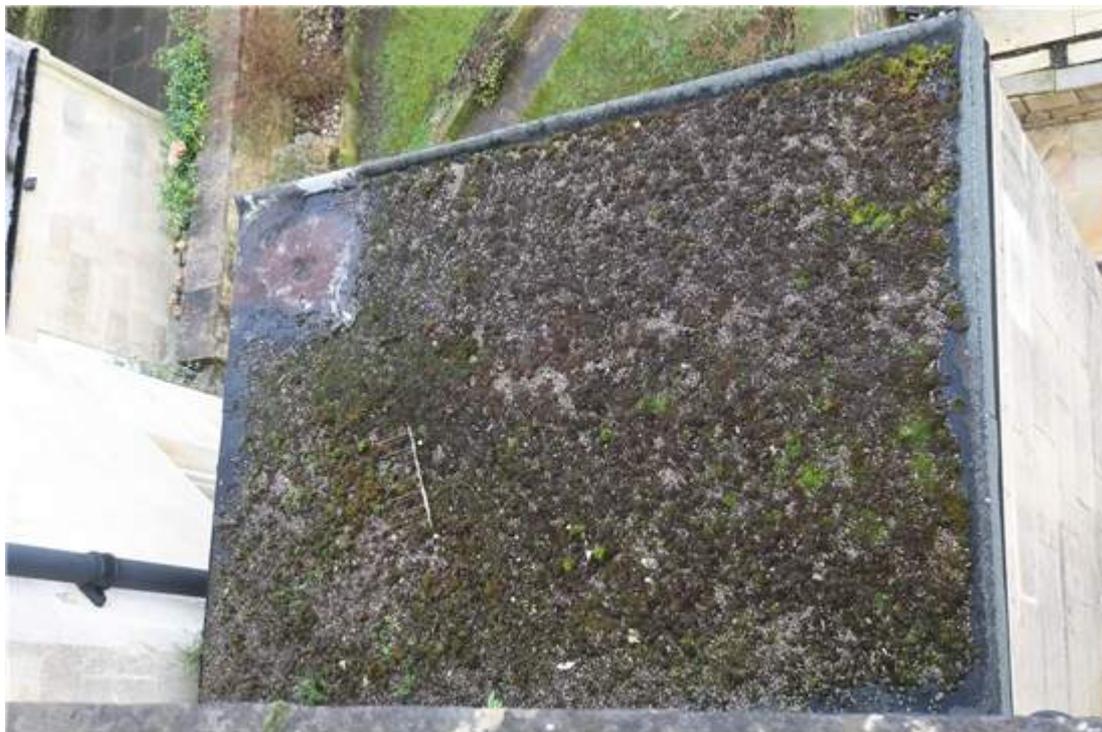
The flat roof above the rear four storey extension is covered in moss and has dated weathering detail to the abutment with the back wall. We noted an area where pooling water has occurred in the past and we would recommend you budget for renewal of the flat roof cover, with the addition of an adequate slope to gutters.

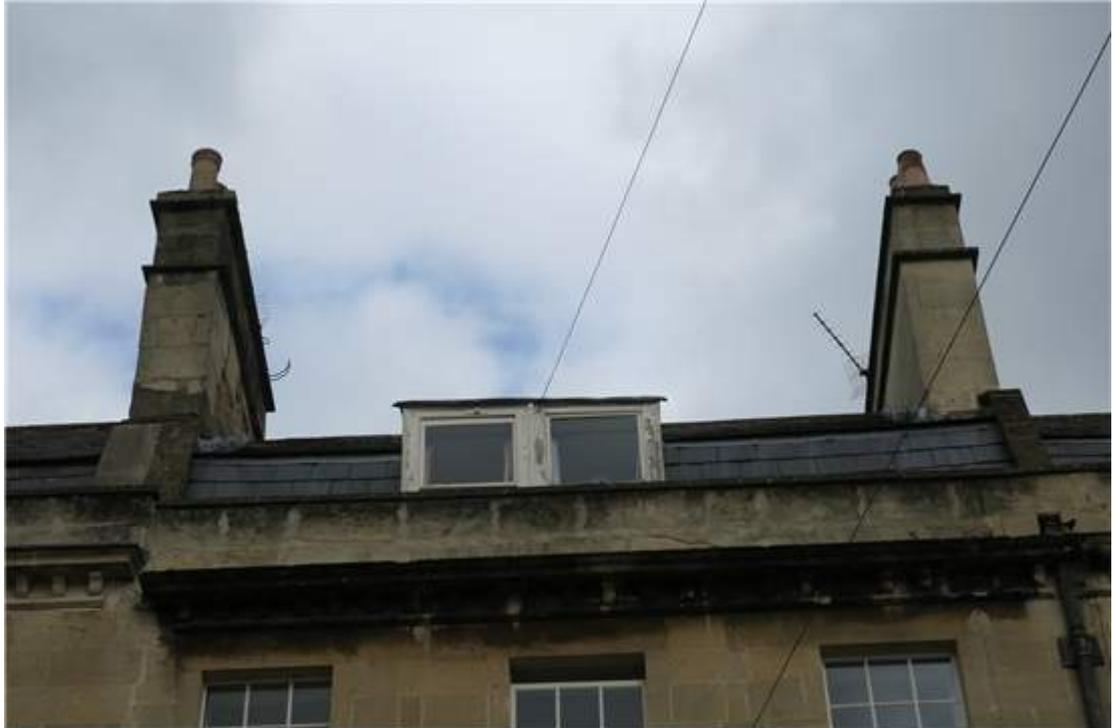
We noted the front roof dormer window to be very dated and in poor condition. The timber frame has areas of rot and glazing to one window is loose and broken. Urgent repair is required to this dormer roof. The front parapet wall has dated pointing and areas of cracking - the stonework requires cleaning and renovating via a stone mason. Decorative frieze above the second floor windows is black from weathering and pollution - this should be cleaned and dressed via a stonemason.

Urgent repairs are required to the front dormer extension frame before the glass panes fall out.

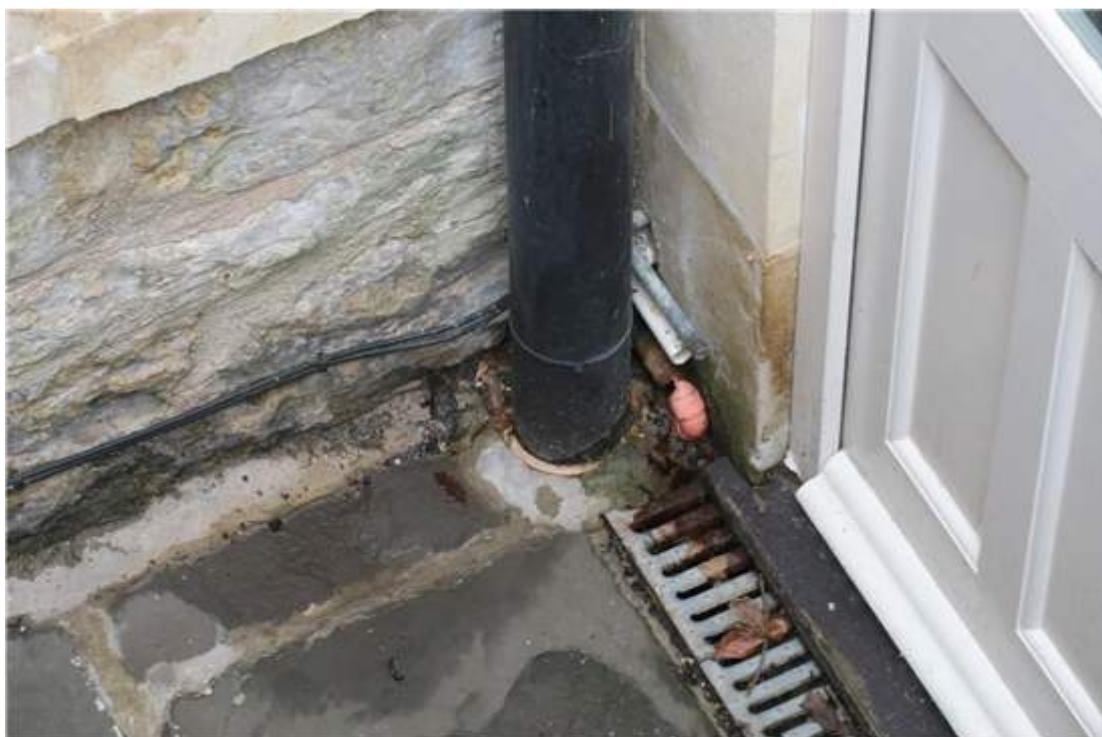
The sunken patio to rear lower ground level has an adequate 'land drain' to direct rainwater away from walls with adequate drainage provision.

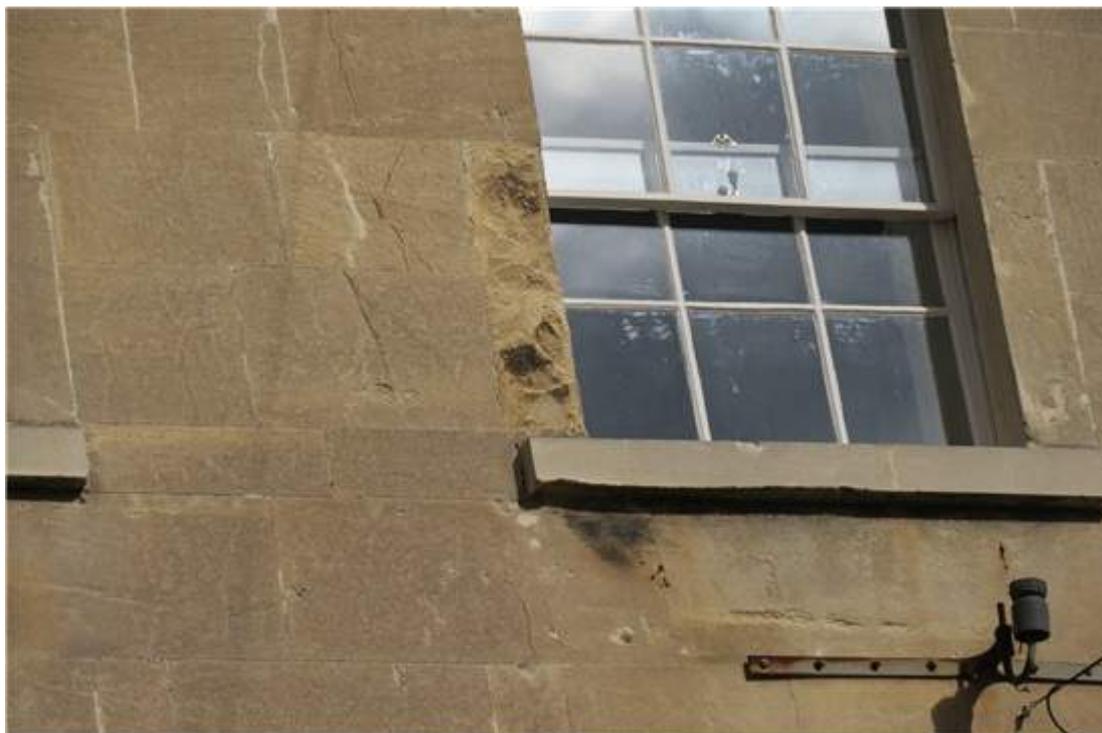
Surface cracking and delamination of stone facings was noted to the Ashlar front cladded walls, repairs and cleaning of stonework is recommended via a stonemason.

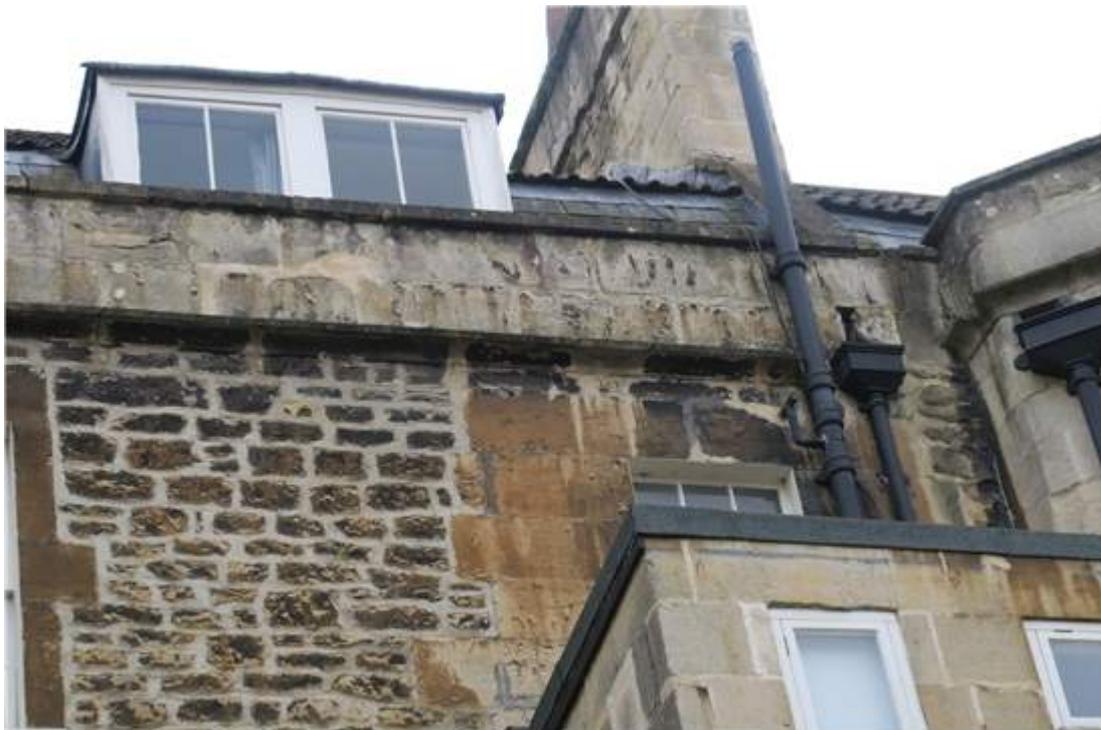
To the rear rubble stone wall finishes have been repaired in the past (above the extension) with replacement in stone block instead of rubble stone. The work is dated and large patch repairs to the extension were also noted - ideally the rear stonework should be cleaned and dressed via a stonemason once the extension roof is repaired.

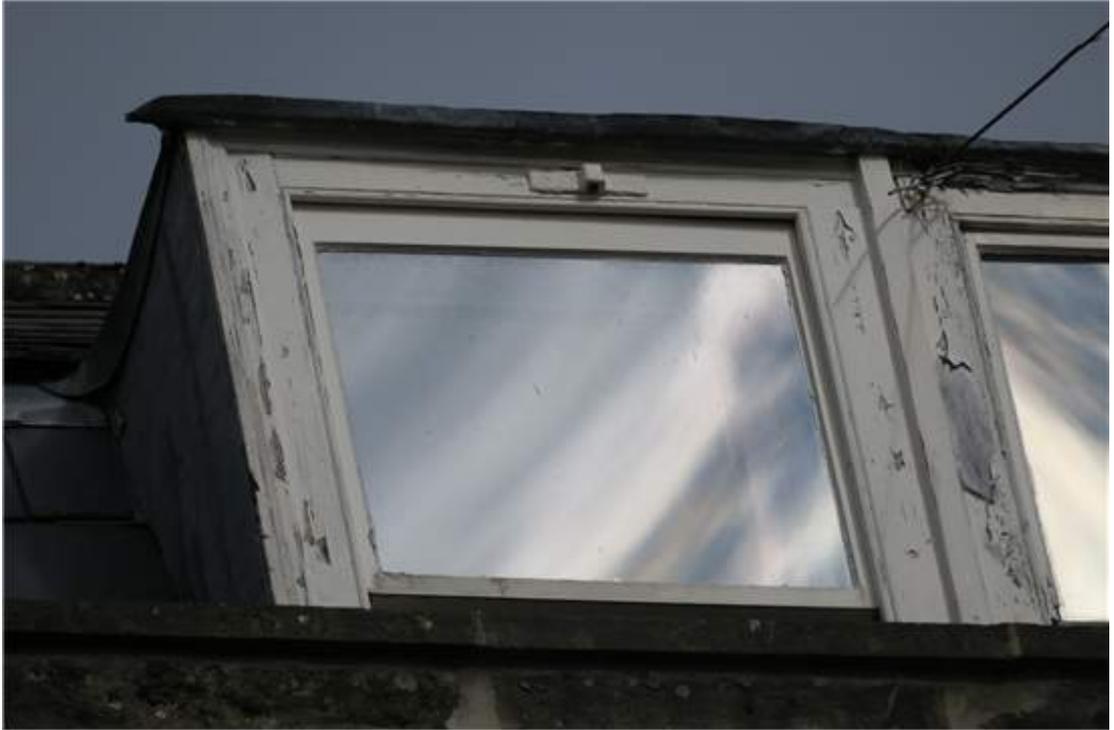
Rot and flaking paint was noted to the front dormer windows which are in very poor condition - urgent repairs are now required.

Window units are of timber sash construction with single glazed panes fitted, and may be original to the building. Window openings to the dormer roof extension need to be replaced as the panes are very loose and are about to fall out, and there is evidence of rot to the frames. I also noted timber shutters have been kept to most windows but I have not checked that they open and close adequately. Areas of peeling paint were noted to most window frames above ground level and repair and redecoration should be anticipated. 2

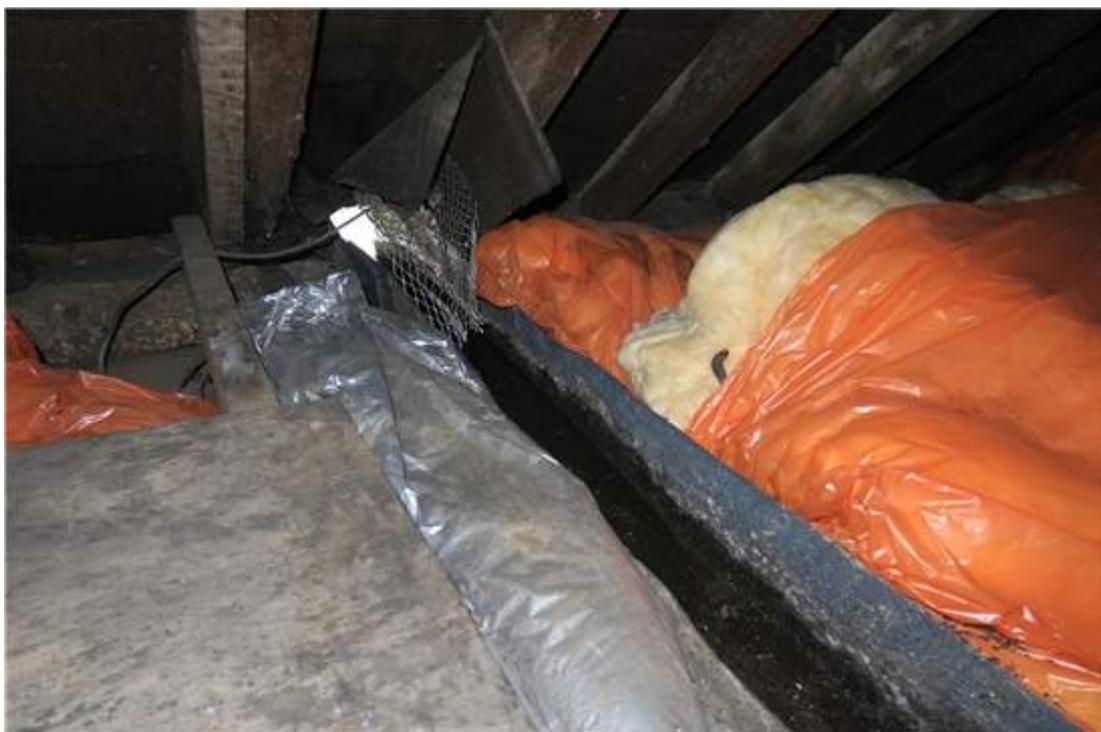
To the rear roof we noted an open 'secret' valley gutter within the roof.

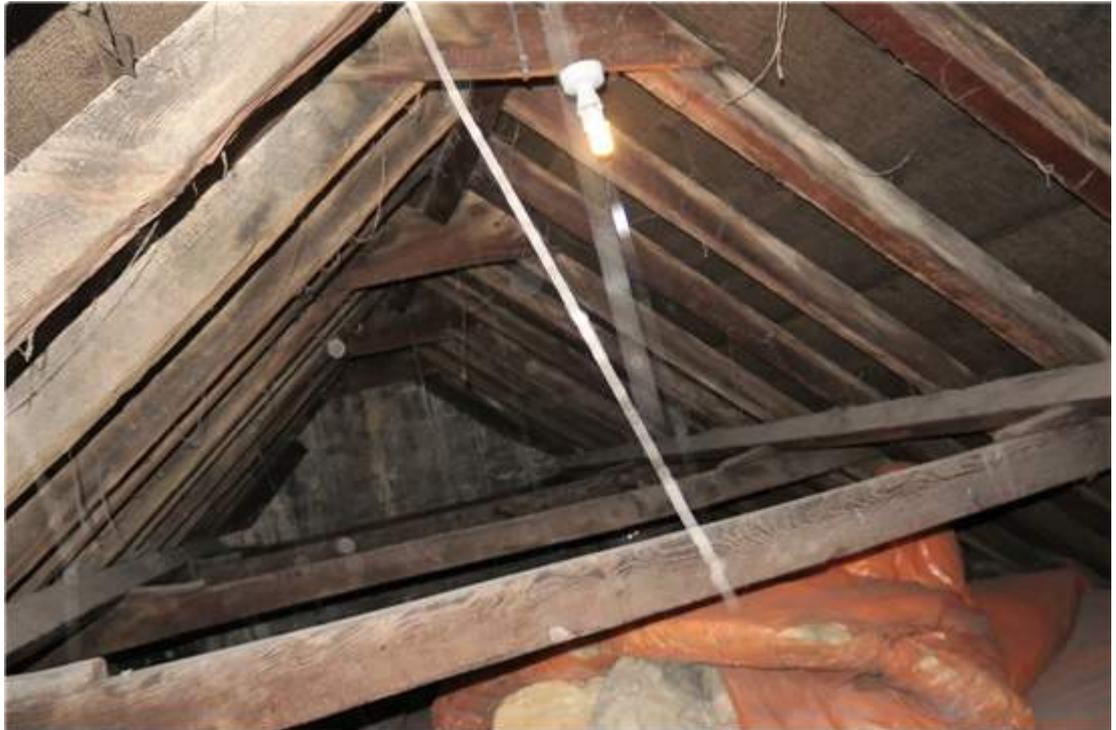
The front roof has areas of brittle felt and dated timbers.
