RICS
Building Survey

Property address	<input type="text" value="Sample"/>
Client's name	<input type="text" value="Sample"/>
Date of inspection	<input type="text" value="09 March 2018"/>

The subject property is a Grade II listed Georgian terraced town house situated above the Royal Crescent and Circus. The property has been converted back to a single dwelling from 4 flats. We noted a planning application to this effect dated from 2007.

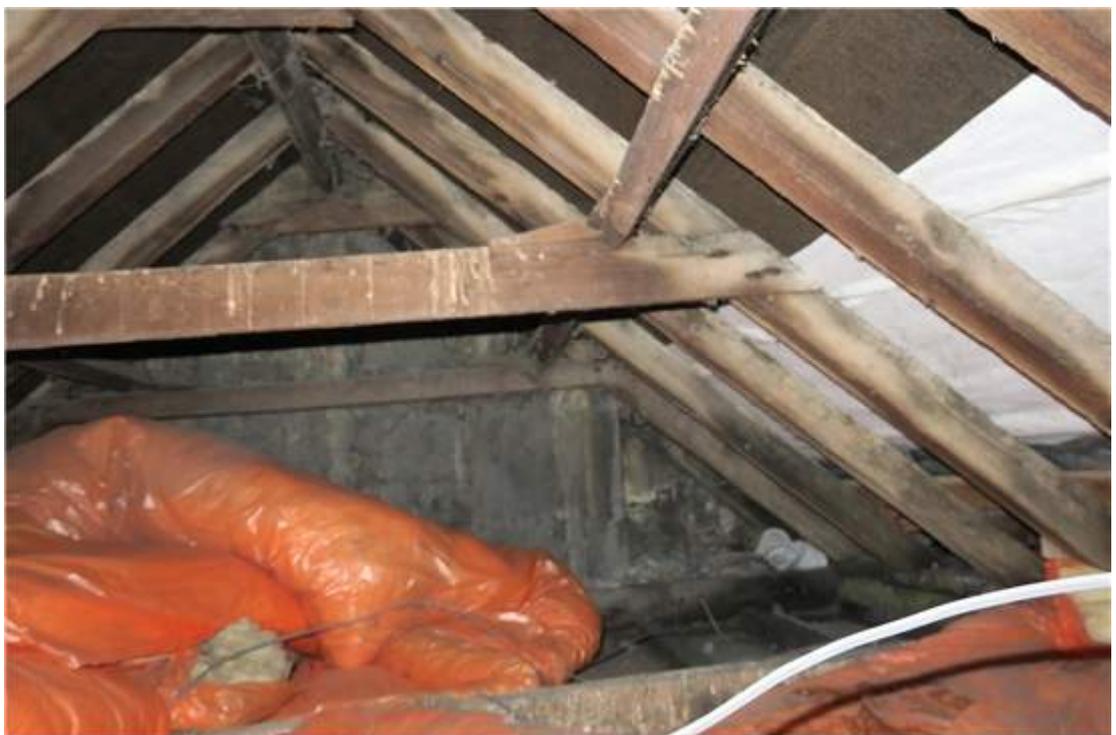
The front roof has areas of brittle felt and dated timbers.

The condition of most of the timbers has been affected by bird droppings and some timbers to the rear left-hand side are stained from a previous leak through the roof. Beetle infestation was noted to some purlin timbers close to the loft hatch and further investigation is required to both the front and rear loft by a timber specialist company. The sarking felt is worn and brittle in places and should be renewed in the short term with a breathable membrane.
